INDOOR AIR QUALITY ASSESSMENT

**Berkshire County Jail and House of Correction
Berkshire County Sheriff's Department
467 Cheshire Road
Pittsfield, Massachusetts**

Prepared by:
Massachusetts Department of Public Health
Bureau of Environmental Health Assessment
July 2003

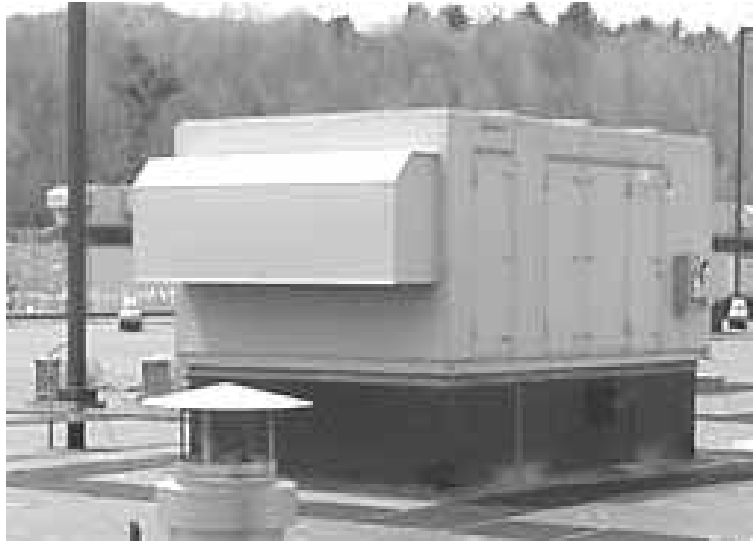
Picture 1

A heating, ventilation and air conditioning (HVAC) system provides ventilation. Fresh air is provided by rooftop-mounted air handling units (AHUs) (Picture 1). These AHUs are connected to ducts that supply fresh air to rooms through ceiling mounted air diffusers. By design, air diffusers are equipped with fixed louvers, which create airflow by directing the air supply along the ceiling to flow down the walls.

Rooftop AHU

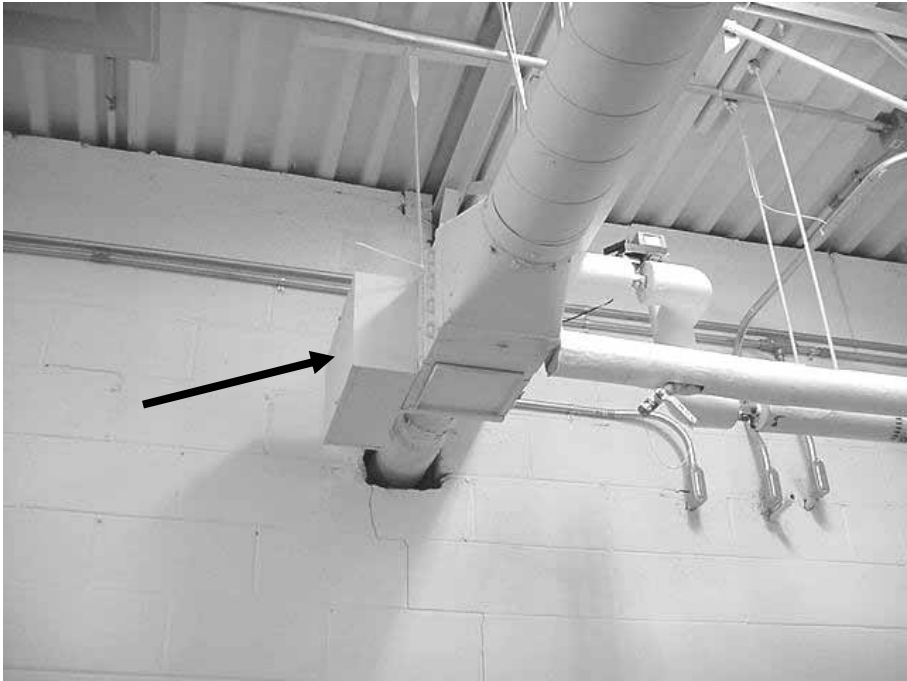
Picture 2

Local airflow to each air diffuser is controlled by a variable air volume (VAV) box (Picture 2). Each VAV box has a set of thermostat-controlled dampers that open or close depending on the temperature demand for a serviced area. Once the thermostat detects that the temperature has reached a predetermined level, the VAV box dampers close until heating or cooling is needed. VAV boxes also control the provision of fresh air to a serviced space. During times that the temperature of a space is adequate, the VAV box closes its damper and limits the amount of fresh air. In contrast, if the thermostat calls for the HVAC system to provide heat, the AHU fresh air intake damper would close to

VAV Box

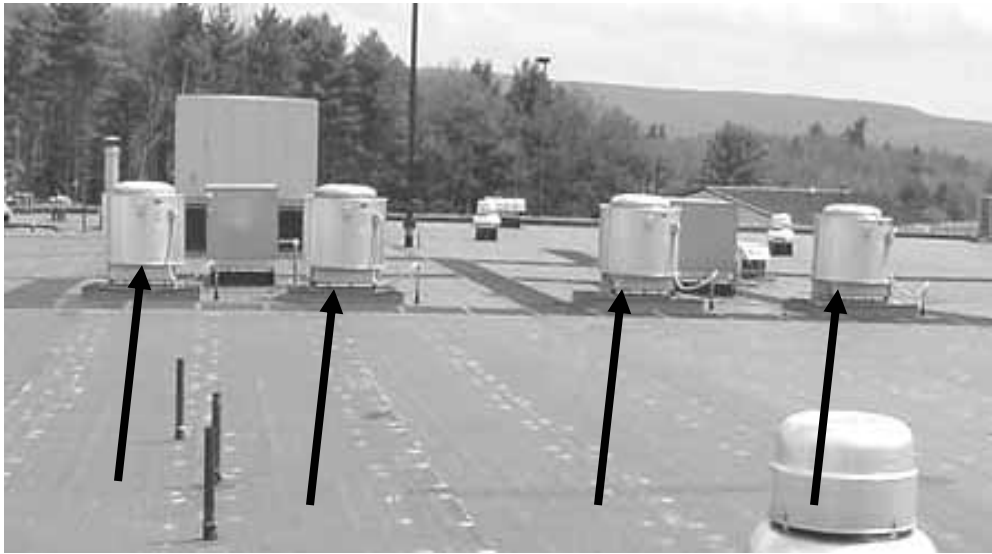
Picture 3

A number of other conditions that can potentially affect indoor air quality were noted during the assessment. Of note is the location of the exhaust vents for the kitchen (Picture 3). These exhaust vents are located west of AHUs for the kitchen (Picture 4) and the large AHU for BCJ offices (Picture 5). Under certain wind conditions, cooking odors and products of combustion from the kitchen exhaust vents may be directed toward the fresh air intake hoods of these AHUs. The height of the boiler vents may also present a re-

Kitchen Exhaust Vents On Roof

1. Consider extending the terminus for the boiler stacks to a sufficient height above the fresh air intake hood of the nearby AHU (Picture 5).
2. Consider extending the terminus for the kitchen exhausts vents at a level above the fresh air intakes for nearby AHUs. If not feasible, consider installing a solid barrier between fresh air intakes and exhaust vents on roof to direct kitchen exhaust odors away from the AHU fresh air intakes.
3. Examine the feasibility of installing local exhaust ventilation for printers in the print shop.
4. Examine the feasibility of installing local exhaust ventilation for the metal grinder.
5. Examine the feasibility of installing an exhaust vent over the wood dust collector to capture respirable dust and vent outdoors.

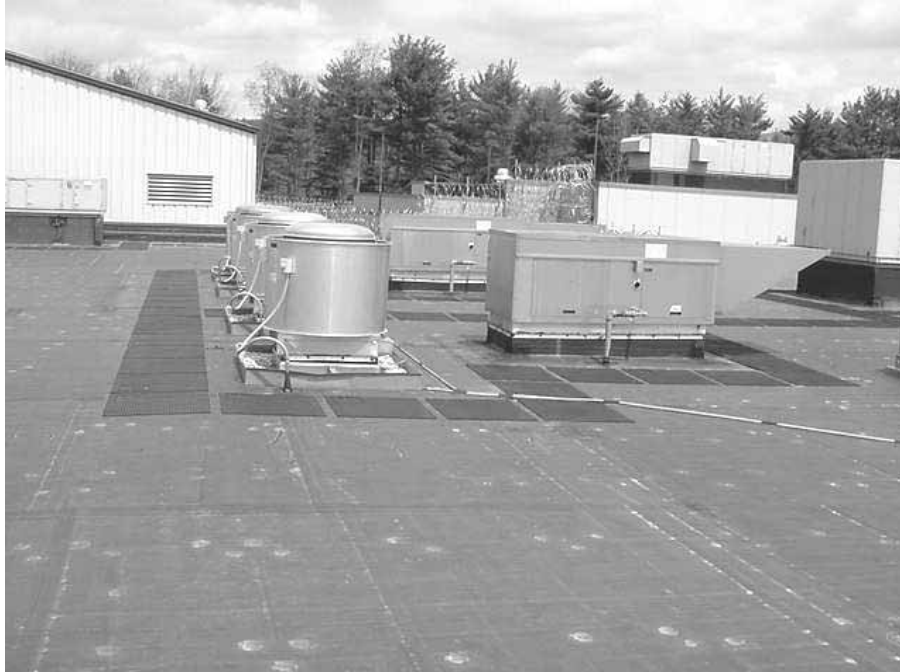
Picture 4

AHUs Are East Of the Kitchen Exhaust Vents

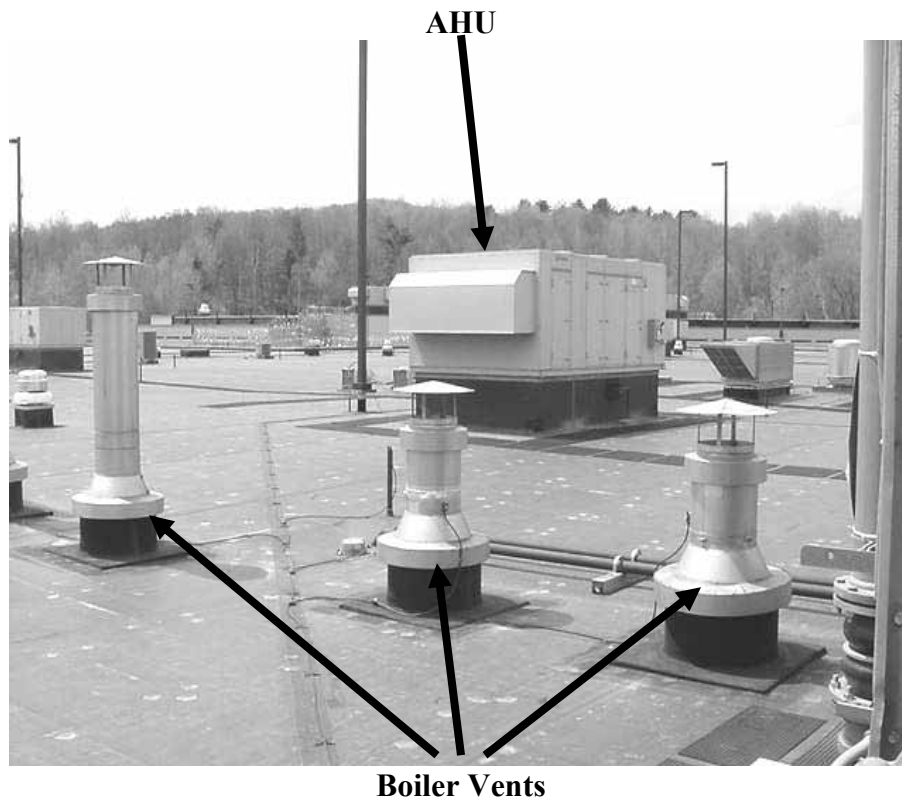
Picture 5

entrainment concern during rare easterly wind conditions (Picture 5). With sufficient air velocity drawing air into the AHU, these products of combustion may be entrained by each AHU and distributed to office space.

Large AHU for BCJ Offices, East of Kitchen Exhausts, Note Height of Boiler Vents on Foreground

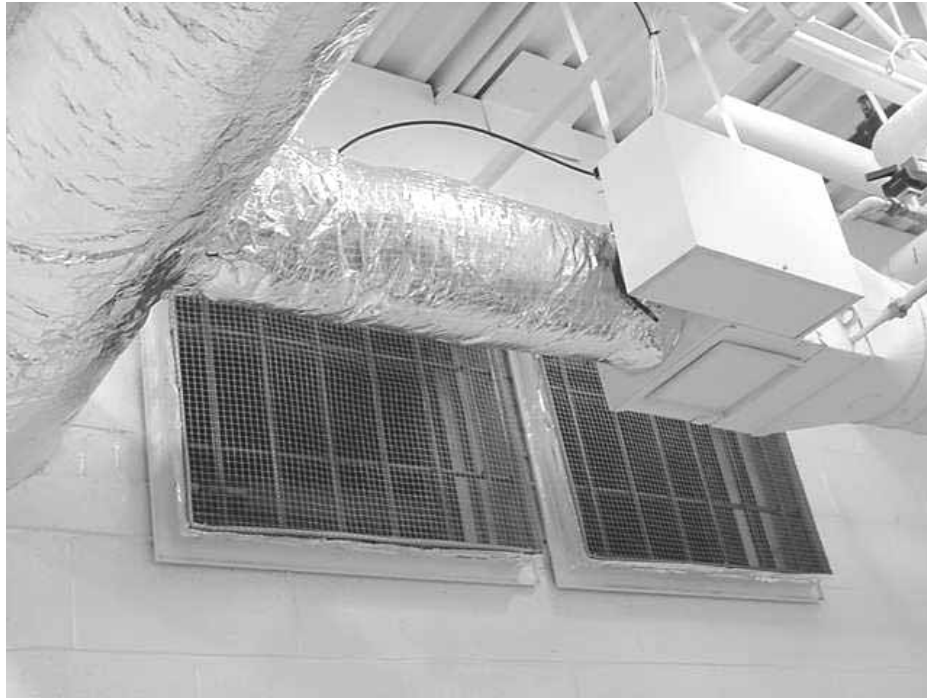
Picture 6

- VE 04 Print Shop: Inside the print shop are a number of printers that use VOC containing materials. Inks, washes and hand cleaners containing VOCs are used in this area. No local dedicated exhaust ventilation exists for any of the printers. Both OSHA and the American Conference of Governmental Industrial Hygienists (ACGIH) have established Permissible Exposure Limits (PELs) (OSHA, 1997) and Threshold Limit Values (TLVs) (ACGIH, 2002) for various VOCs. It appears that the return vent for the general ventilation system is the sole exhaust vent in this room (Picture 6). In this configuration, pollutants created by use of printing machinery can aerosolize VOCs, which are then be drawn into the AHU and may be distributed to other areas serviced by the vocational education area's HVAC system. The ACGIH has recommended standards for local exhaust ventilation for specific operations such as printing presses (ACGIH, 1998). If this is not practicable, personal protective equipment fit-tested for each individual should be considered.

Exhaust Vents in Print Shop VE 04

1. Seal the return vent in the print shop (Picture 6). Install a rooftop exhaust vent system in the print shop ceiling, similar to systems in rooms VE 01 and VE 02.

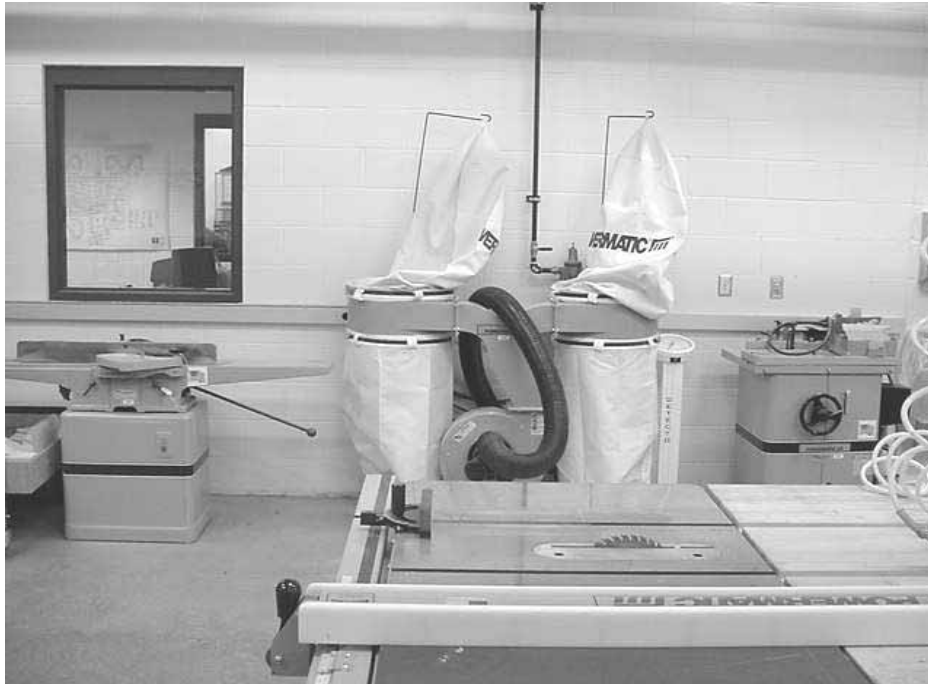
Picture 7

- VE02 Carpentry Shop: Spaces, noted at the bottom and between hallway doors, can allow for sawdust and other pollutants to migrate from the shop to the hallway. The shop does not have a ducted collection system for dust generating machinery (e.g. saws, sanders). It appears that wood particles are filtered through a portable collection unit (Picture 7). It is recommended that wood dust be removed from the environment at the point of generation using a dust collection system to prevent dust aerosolization. Wood dust can be irritating to the eyes, nose, throat and respiratory system.

Wood Dust Collector

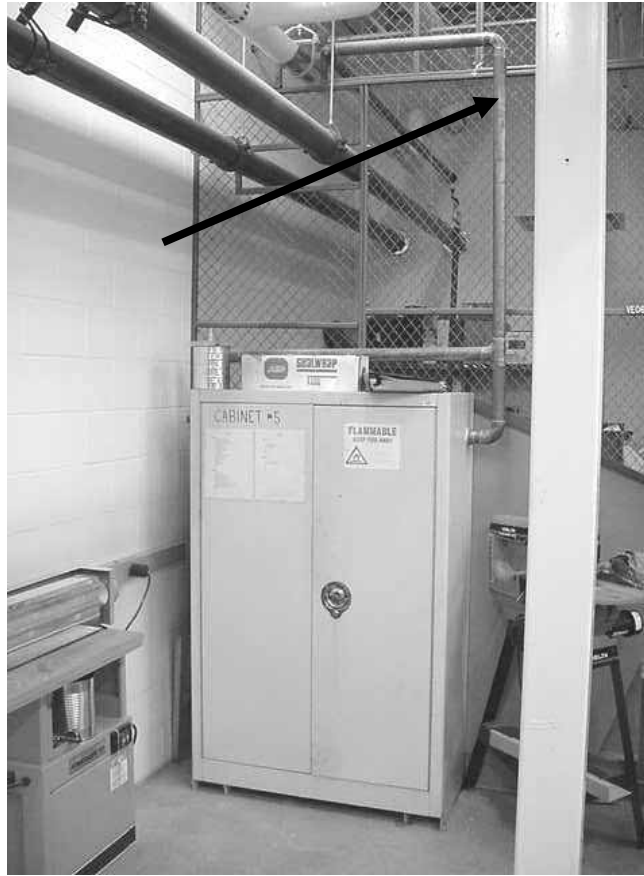
Picture 8

- Flammable Chemical Storage in VE Area: Flammable materials in shops are stored in flameproof cabinets (Picture 8). An exhaust vent was installed to each flameproof cabinet. The National Fire Prevention Association (NFPA) does not require venting in flammable storage cabinets, however, if venting is done, it must be vented directly outdoors and in a manner that does not compromise the specific performance of the cabinet (NFPA, 1996). If air backflow from outdoors into the cabinet through the venting occurs, off-gassing chemicals can be forced from the flammable storage cabinet into the storeroom. Proper design of exhaust vents should prevent air backflow into the cabinet. The installation of the exhaust vents

Flameproof Cabinet, Note Copper Pipe Serving As Exhaust Vent

2. Disconnect the flammable storage cabinet from the PVC pipes and reseal the cabinet with its original bung hole caps.
3. Seal all holes in interior walls of VE shops to prevent pollutants from penetrating into the ceiling plenum.

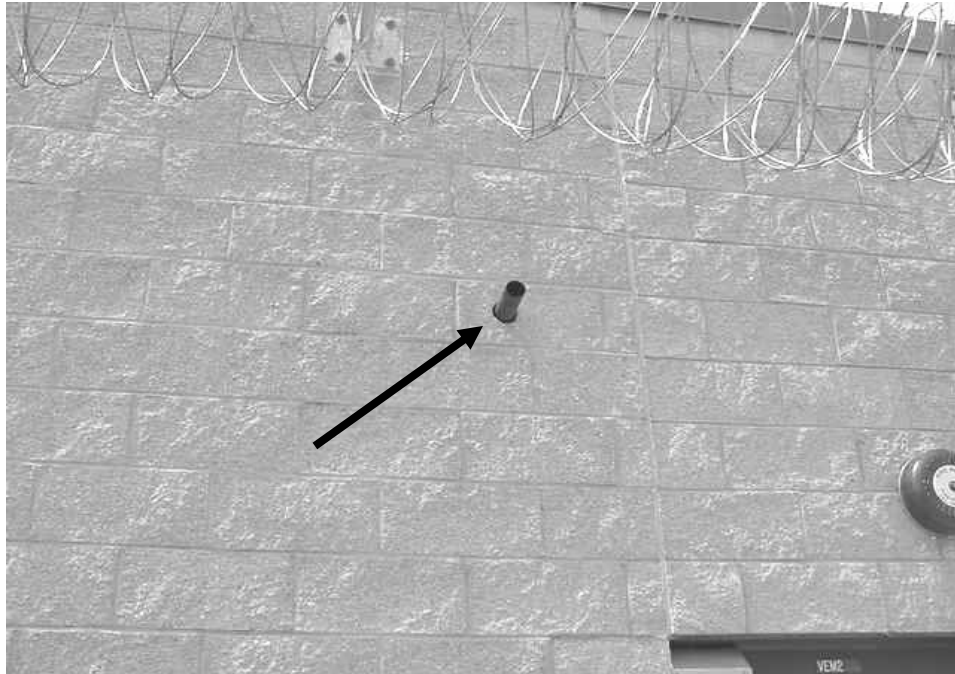
Picture 9

has compromised the fire integrity of the cabinets. Copper pipes were connected to each flameproof cabinet to serve as vents (Picture 9). Each vent pipe is installed through the BCJ exterior wall (Picture 10). No air backflow device could be identified in these vent pipes. In their current condition, these pipes can provide an oxygen supply to the interior of each flameproof cabinet.

Flameproof Cabinet Exhaust Vent Pipe Terminus, Exterior Wall

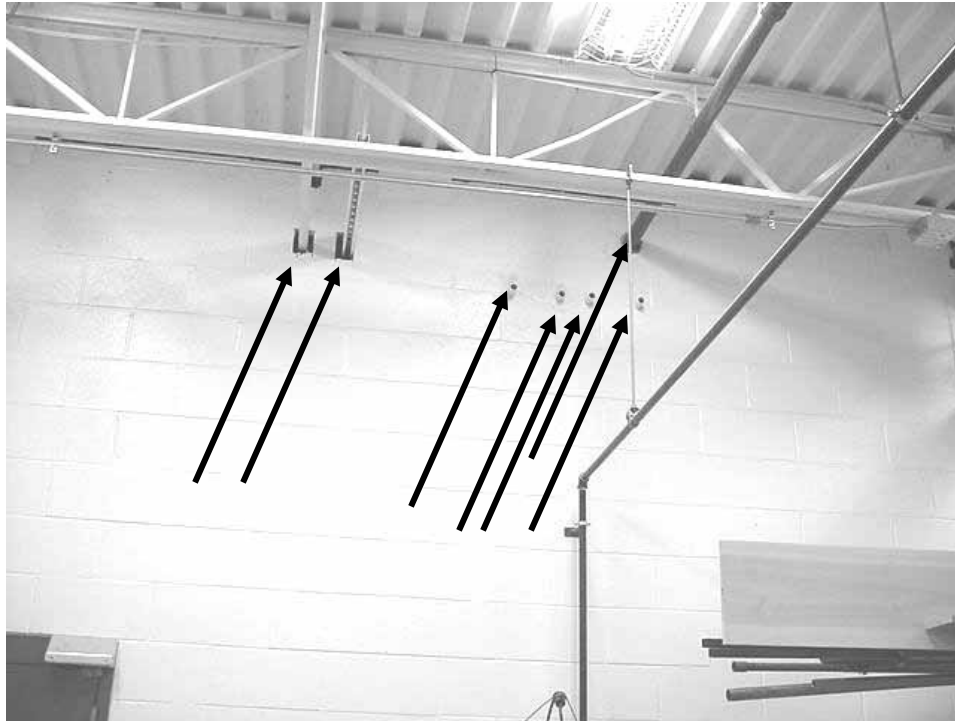
Picture 10

Also of note is the number of holes in interior walls of VE shops (Pictures 10 & 11). As discussed in the Ventilation Section of this report, the return system for the building is a plenum type system. In this configuration, the area above the ceiling becomes depressurized as the AHU operates. Depressurization causes air and airborne pollutants to be drawn into the plenum system through these holes and become redistributed to other areas served by the AHU.

Holes in Interior Wall, VE Room

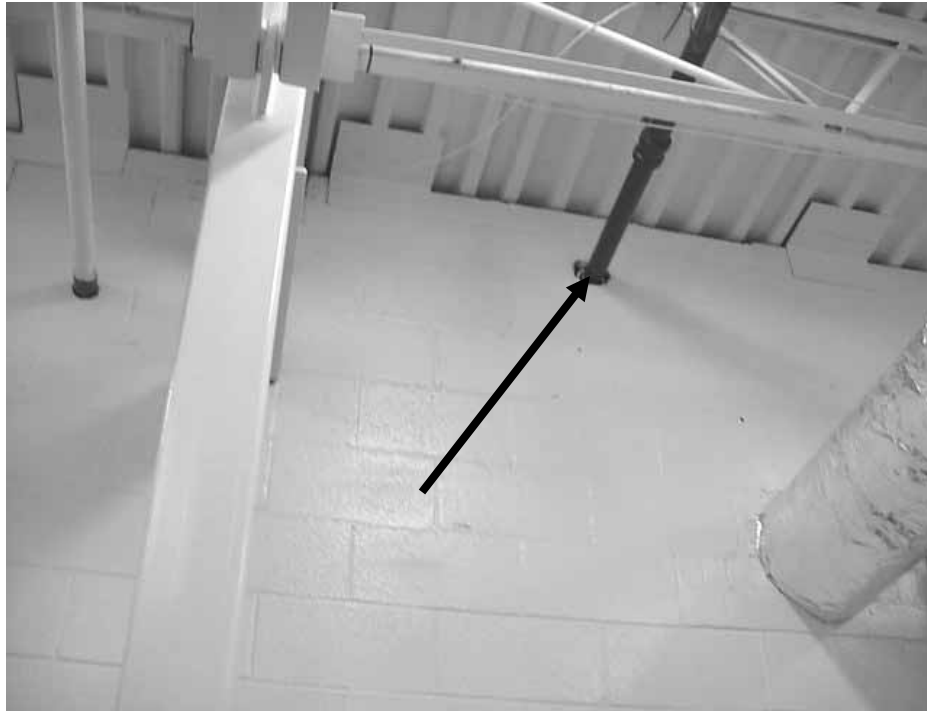
Picture 11

Hole in Interior Wall, VE Room
